# Chernobyl accident: Causes, consequences and problems of radiation measurements

V. Kortov\*, Yu. Ustyantsev

General description of Chernobyl accident is given in the review. The accident causes are briefly described. Special attention is paid to radiation situation after the accident and radiation measurements problems. Some data on Chernobyl disaster are compared with the corresponding data on Fukushima accident. It is noted that Chernobyl and Fukushima lessons should be taken into account while developing further measures on raising nuclear industry safety.

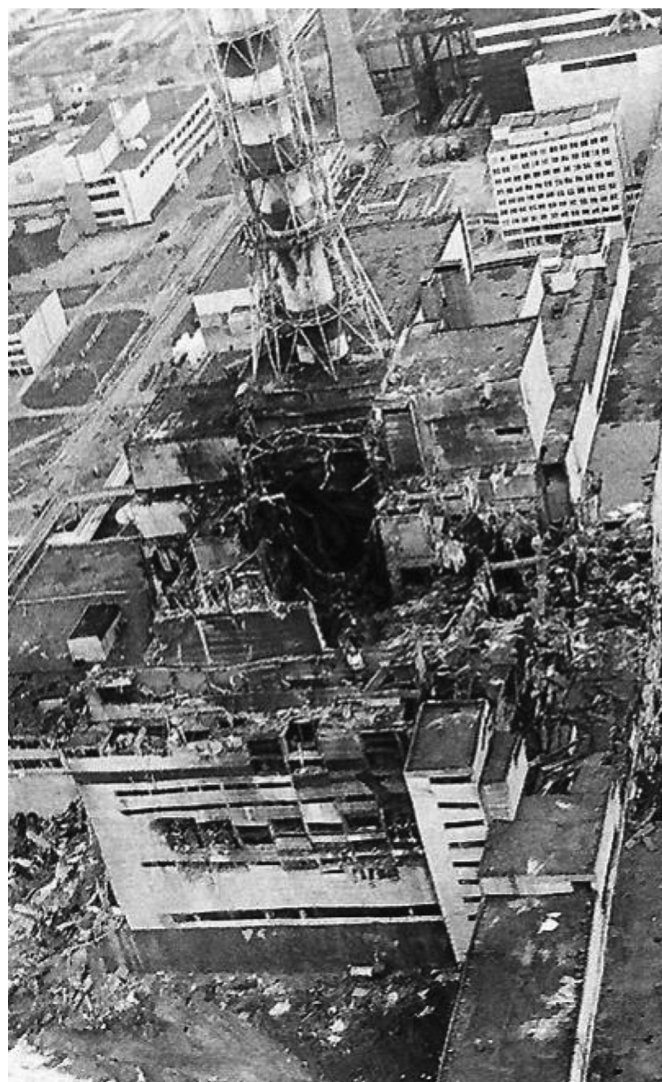
Fig. 1. Photo of the destroyed reactor at Chernobyl NPS.

The accident occurred during the scheduled tests of power supply mode in case of external sources loss. This mode was conceived in the test program and was to be launched if the reactor capacity dropped by 30% accompanied by emergency cooling system shut down. In this term there is some similarity with Fukushima accident, when the emergency cooling systems were destroyed by the earthquake and tsunami. The Fukushima reactors, however, were shut down immediately after the first shock of the earthquake. The Chernobyl staff in absence of the emergency cooling lowered the reactor capacity down to inadmissible low level (20% from the nominal capacity). Constructional and physical characteristics of RBMK-1000 reactor did not allow the staff to effectively control its work at such low capacity. However, (Summary Report, 1986) the scheduled tests were completed and the staff received the command to shut down the reactor. It was this scheduled procedure that appeared to be the accident cause. The insertion of the protection rods into the reactor core at low reactivity level did not bring the reactor to a halt. On the contrary, it led to sharp increase in reactivity, reactor power growth and fast heating of the reactor active zone which caused the explosion. The photo picture of the explosion destroyed part of the reactor core and reactor building at Chernobyl is shown in Fig. 1.

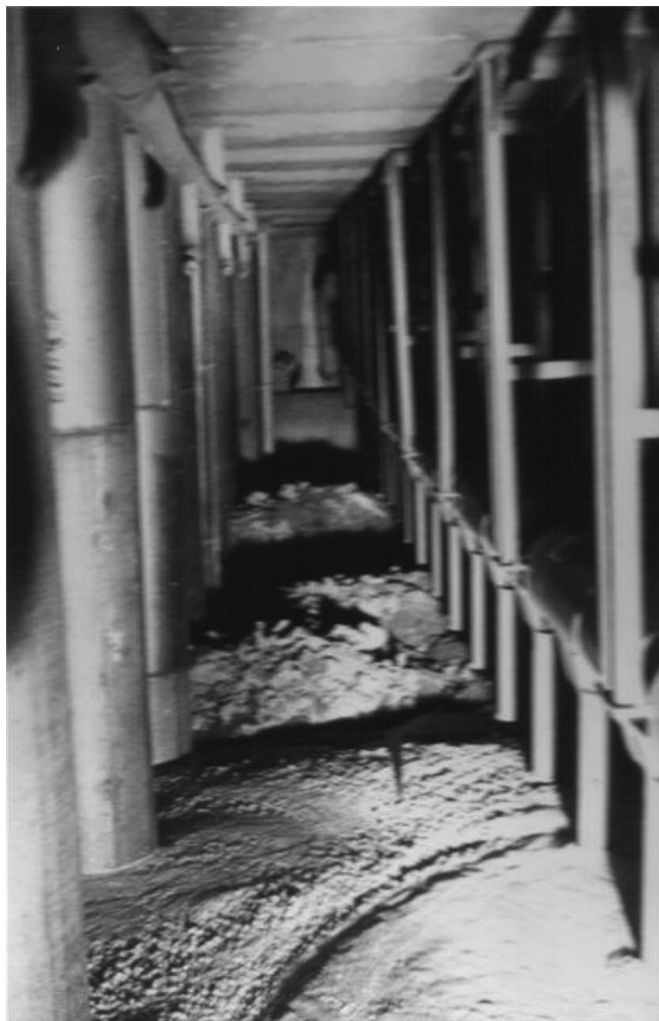
Fig. 2. Floats of fuel-containing substances under reactor.

Explosions and ejection of radioactive substances and fire lasted for 10 days. The active zone of reactor was damaged and nuclear fuel was melted as shown in Fig. 2. 70 tons of nuclear fuel was ejected by the exploded reactor. Another 50 tons of nuclear fuel and 800 tons of graphite burned down in the destroyed reactor.

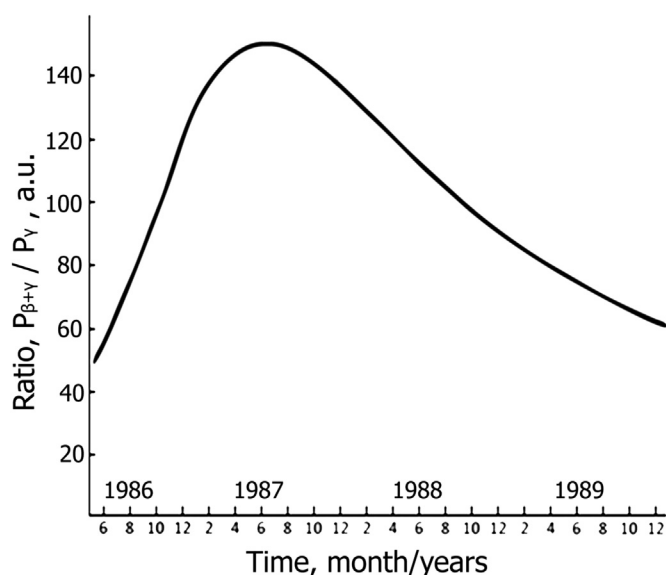
Fig. 3. Dependence of ratio  $P_{\beta+\gamma}/P_{\gamma}$  on time after Chernobyl accident.

An increase of contribution ratio of  $\gamma + \beta$  radiation to  $\gamma$ -radiation was observed during the long (about a year) period, due to changes of radioactive nuclides composition because of the short-lived isotopes break-up (Fig. 3). That caused a rise of  $\beta$ -radiation part in mixed  $\gamma + \beta$  radiation fields.

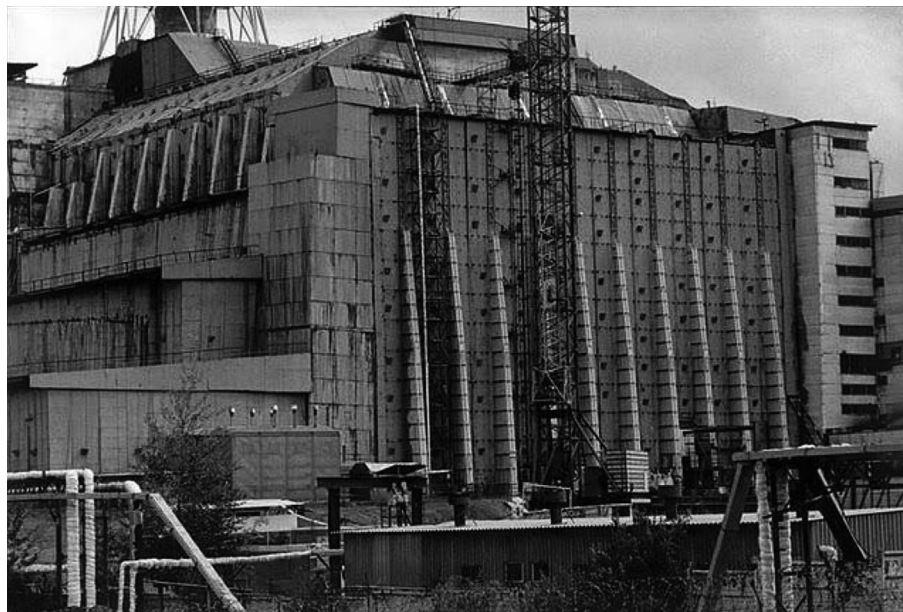
Fig. 4. Photo of Chernobyl reactor shelter (April, 2011).

There are the problems of shelter (Fig. 4). The shelter erection was an important event in stabilization of radiation situation near the destroyed reactor. The shelter however was not able to solve a set of problems connected with the ecologically safe system of environmental protection from the radioactive pollution caused by destroyed reactor.

According to the calculated data, inside the shelter there is still about 95% of the irradiated nuclear fuel (Krupny, 1996). It is found in the fragments of the reactor core, in the fuel dust and in the lava materials. Total activity of radionuclides inside the shelter at present is about  $4.8 \cdot 10^{17}$  Bq (Baloga, 2011). Radiation hazard is presented by aerosols responsible for air pollution inside as well as outside the shelter. There are still rooms inside the shelter where expose dose rate is over 10 Gy/h, though in most rooms it does not exceed 10 mGy/h. Some aerosols leak through crevices and technical hatches in the shelter forming “unexpected” radioactivity release. As a result, expose dose rate 150 m from the shelter is about 0.15 mGy/h (detected by V. Kortov 26.04.2011) which is 1000 times as much as natural background.
